Phase I Environmental Site Assessment

**132 Acres
Camarillo Regional Park
Camarillo, California**

Rincon Consultants, Inc.
September 15, 2008

September 15, 2008
Project 08-26070

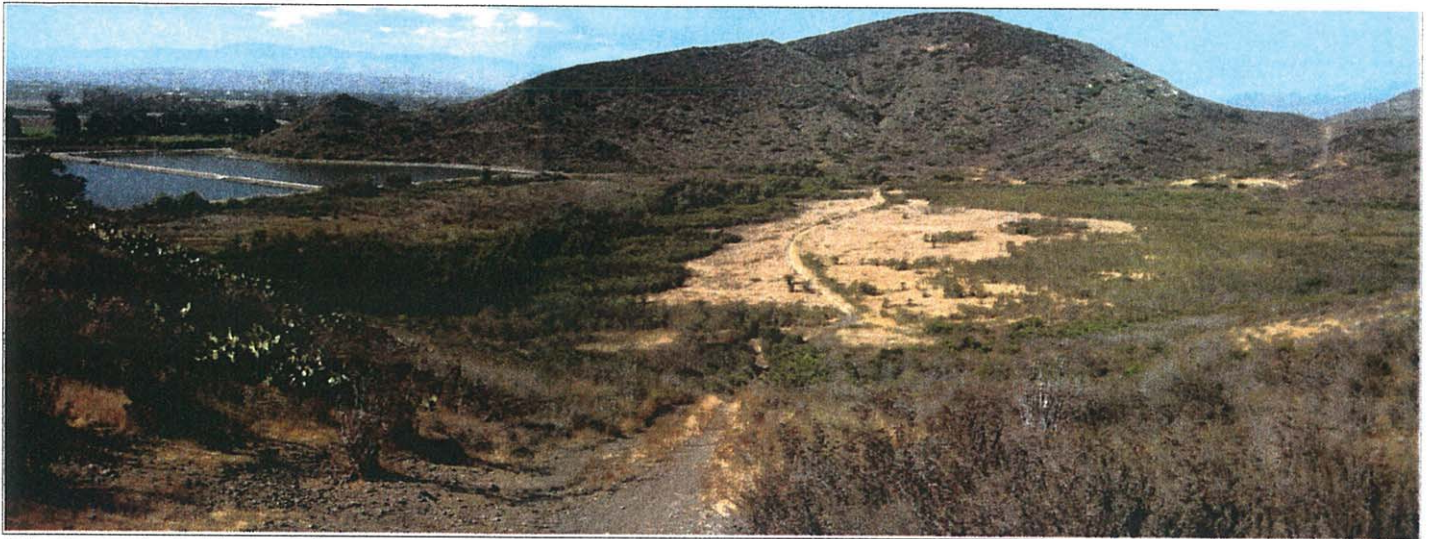
Photograph 1 -View of the larger parcel, adjacent retention ponds and adjacent agricultural property in the background, facing northwest to northeast.

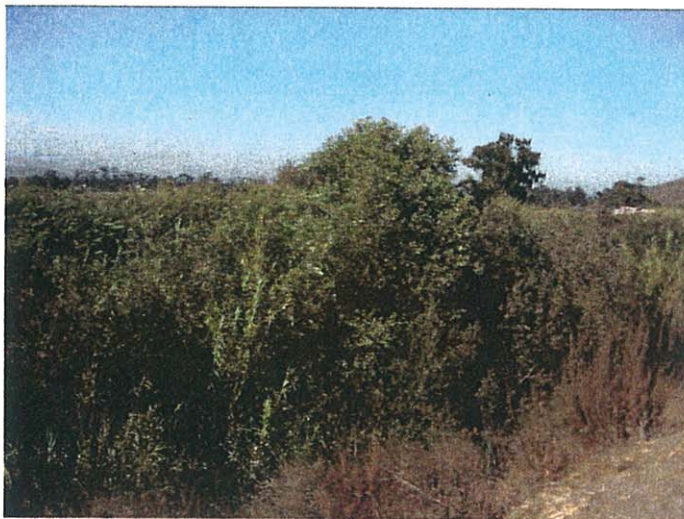
Photograph 2 -View of Calleguas Creek on the northwest portion of the larger parcel, facing north.

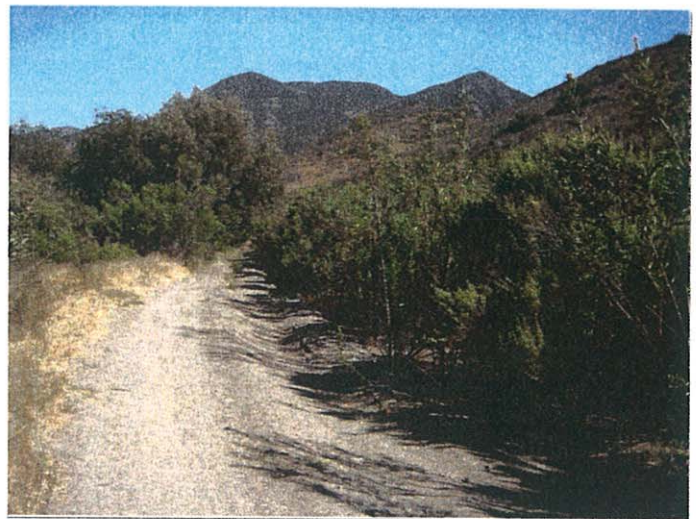
Photograph 3 -View of unpaved road along the southern boundary of the larger parcel.

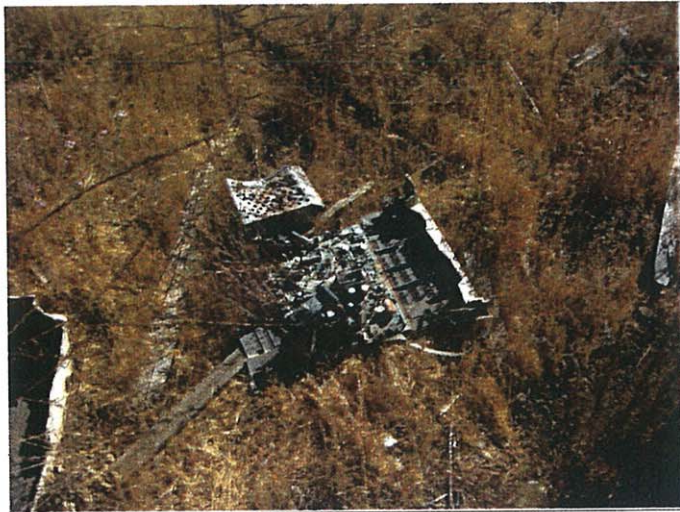
Photograph 5 -View wood, metal and electronic debris located in the southeastern portion of the larger parcel.

Minor amounts of miscellaneous wood, metal and electronics debris were observed along the dirt road in the southeastern portion of the larger parcel. The debris should be properly disposed.

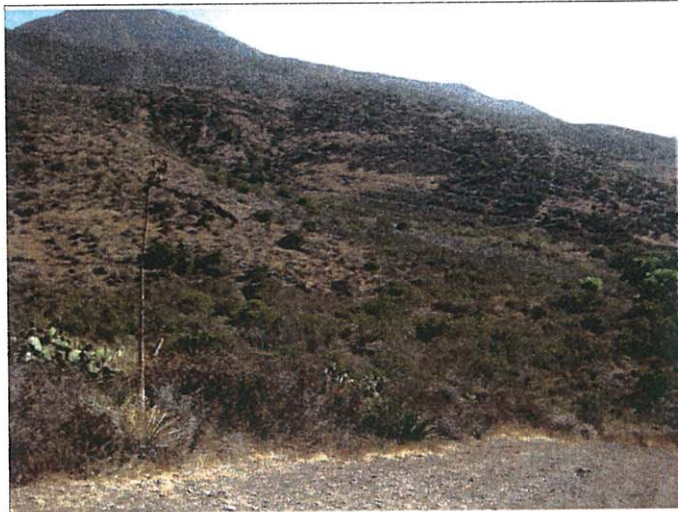
Photograph 7 - View of smaller parcel, facing southwest.

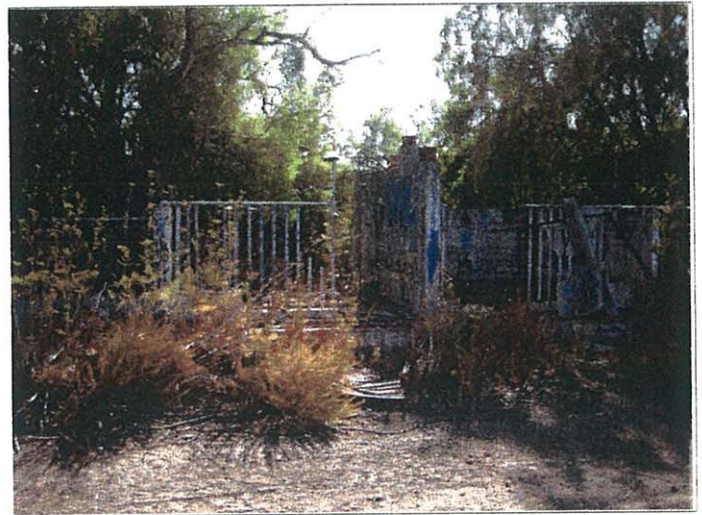
Based on the abandoned structures observed during our site reconnaissance, it appears that the adjacent property to the northwest of the smaller parcel was used as a dairy farm. The presence of several farm-related structures, including a barn, confirmed the former presence of the dairy operation and pig farm that Ms. Lubin described in her questionnaire.

Photograph 8 - View of abandoned dairy or pig farm structure located adjacent to the north of the smaller parcel.
